FIXED POINT FIRE DETECTION

THE LOOKOUTS

By: Mark V. Thornton

November 1986

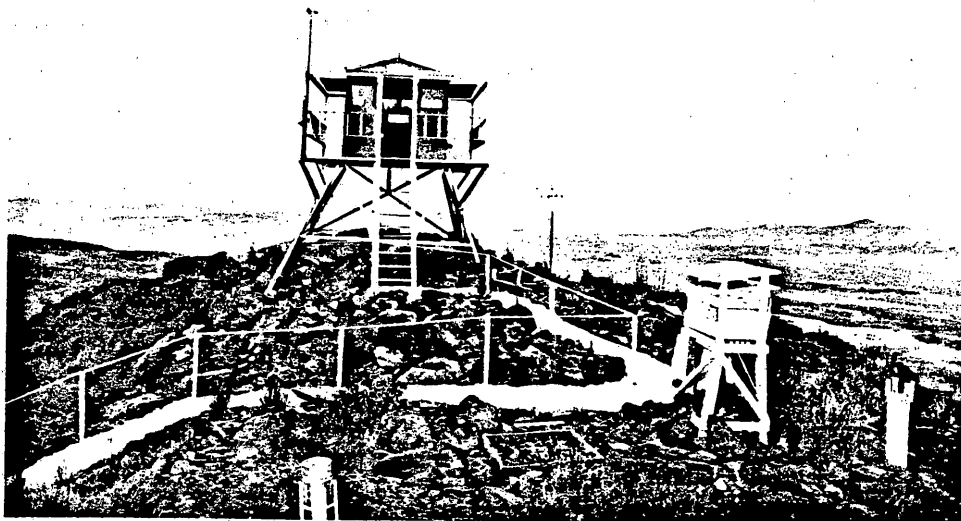
Metal cab on steel tower. Observation Peak, B.L.M.

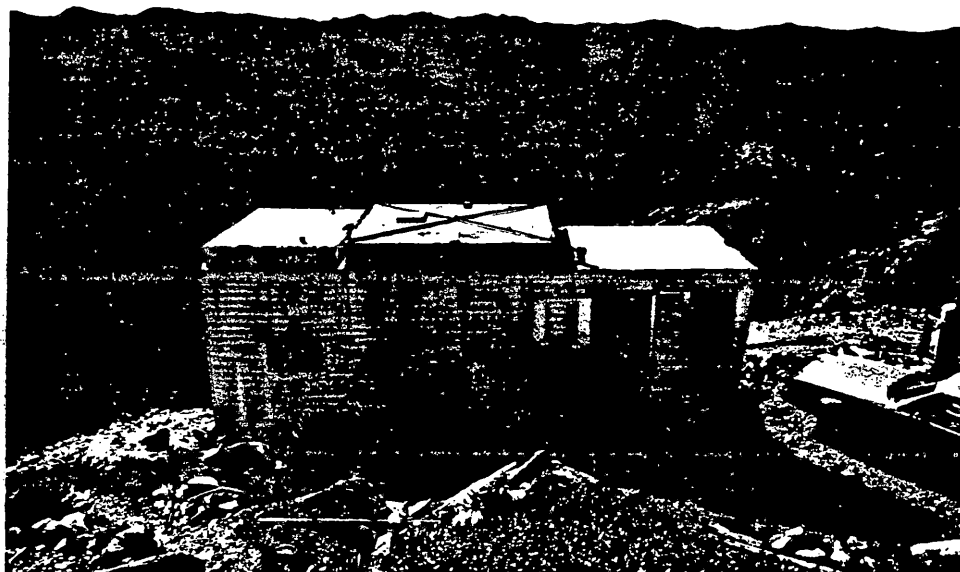
R1M with cupola removed. Ship Mountain, Six Rivers N. F.

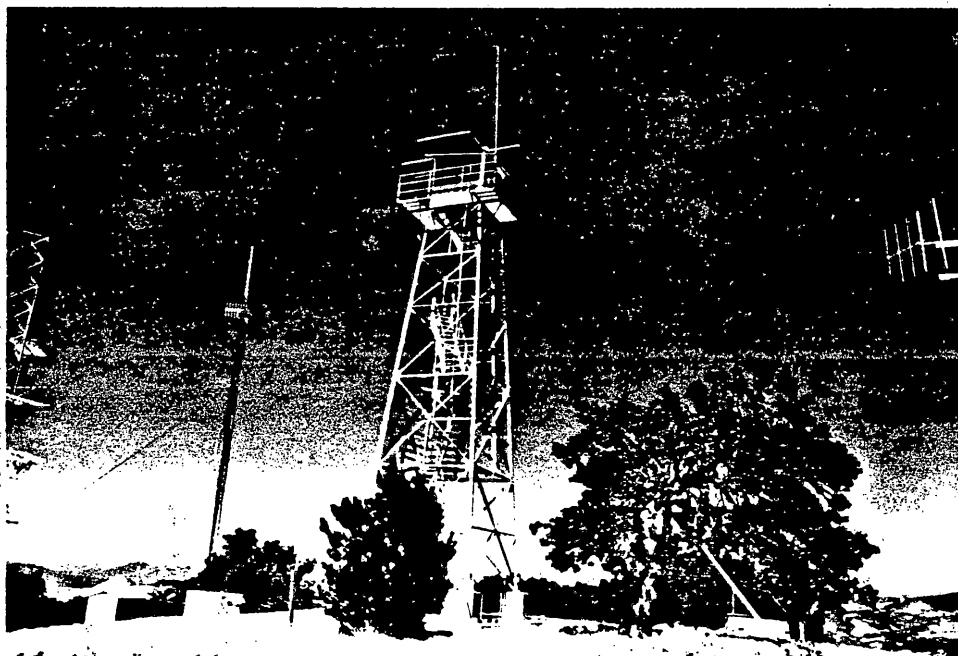
49' tower with catwalk. Pratt, Coast Region, C.D.F.

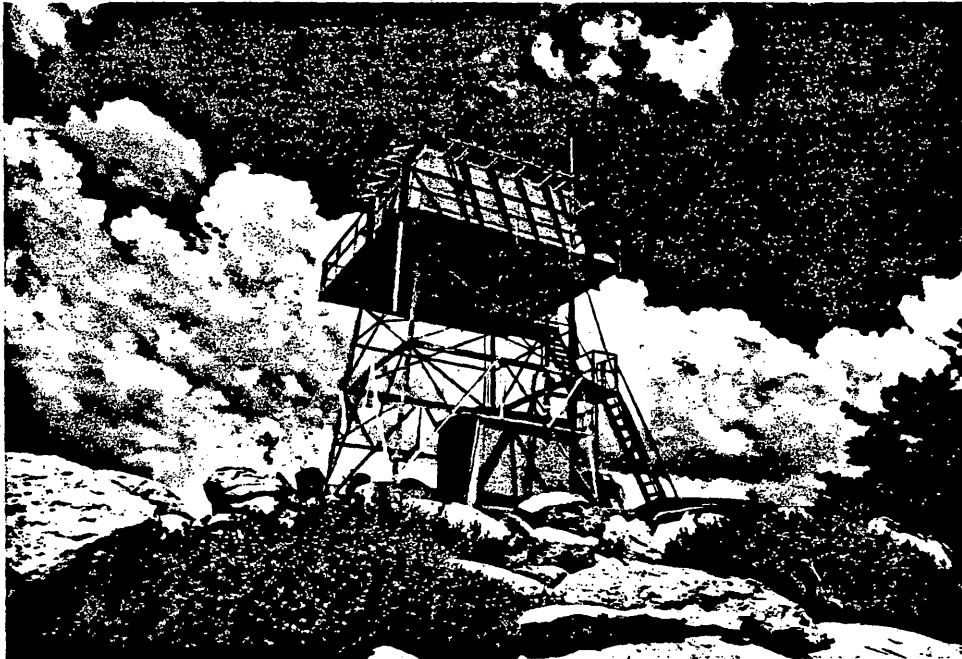
R1 on K,X-B. Keller Peak, San Bernardino N. F.

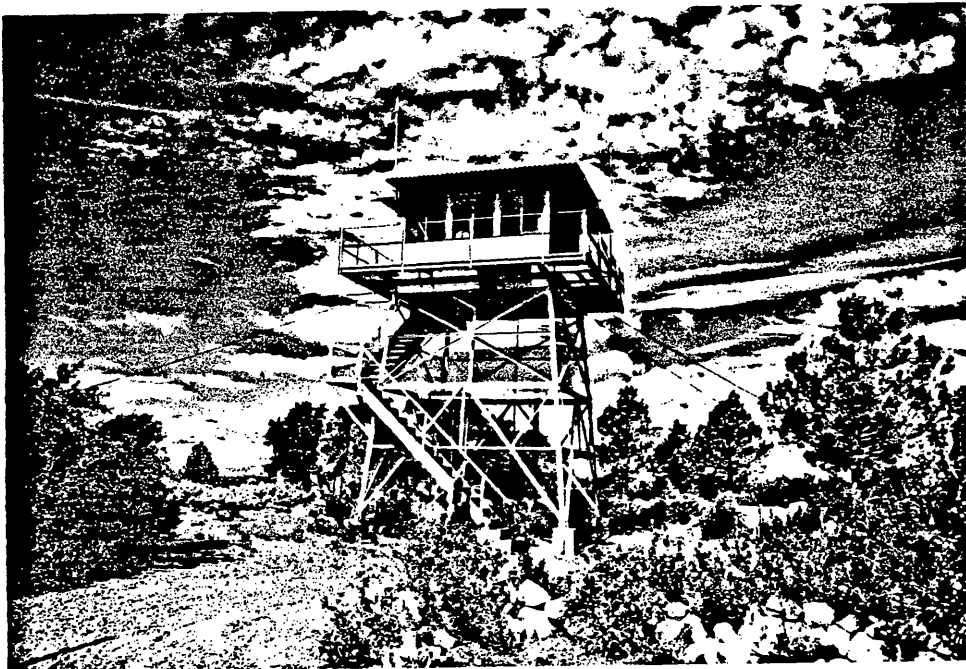
C16 on K,X-B. Blue Mountain, Modoc N. F.

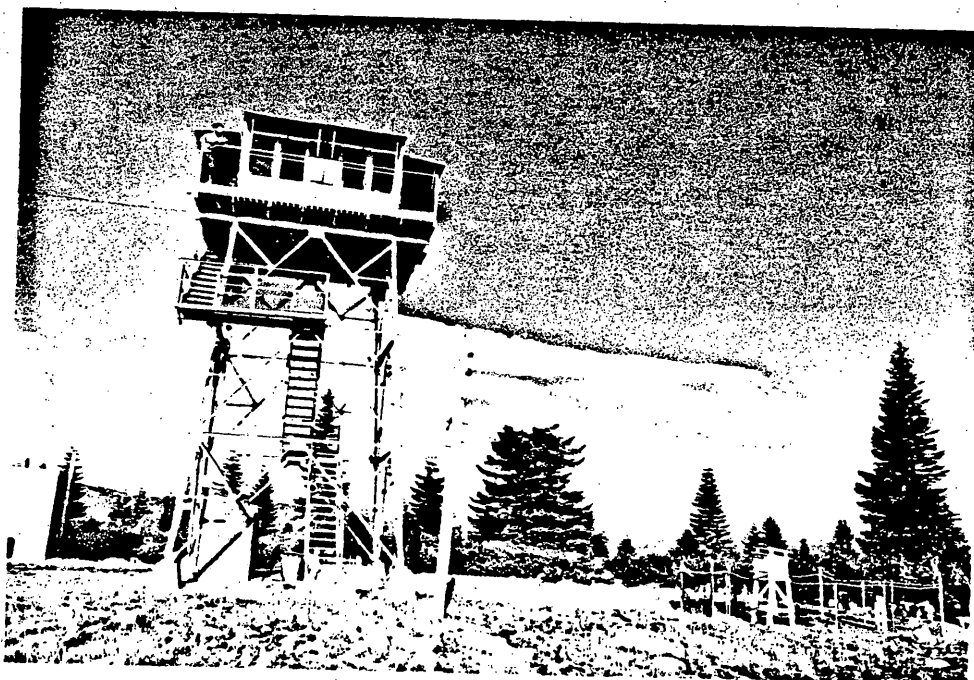
30' K-B, stairs with landings. Colby Mountain, Lassen N. F.

- 20) Approximately 1937, K-brace towers began using stairways with landings.²⁸
- 21) As late as 1937, Region 5 still did not approve of the construction of towers in excess of 30' for the support of live-in observatories; when conditions necessitated taller structures then observation only towers (Aermotor design up to 120') were required.²⁹

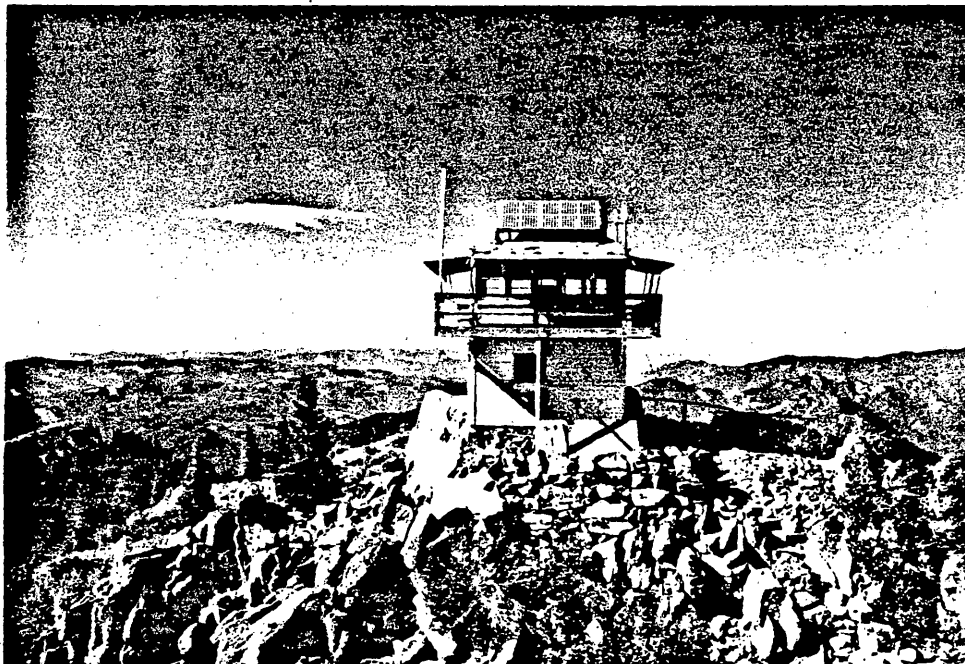
10' NETT. Orleans Mtn., Six Rivers N. F.

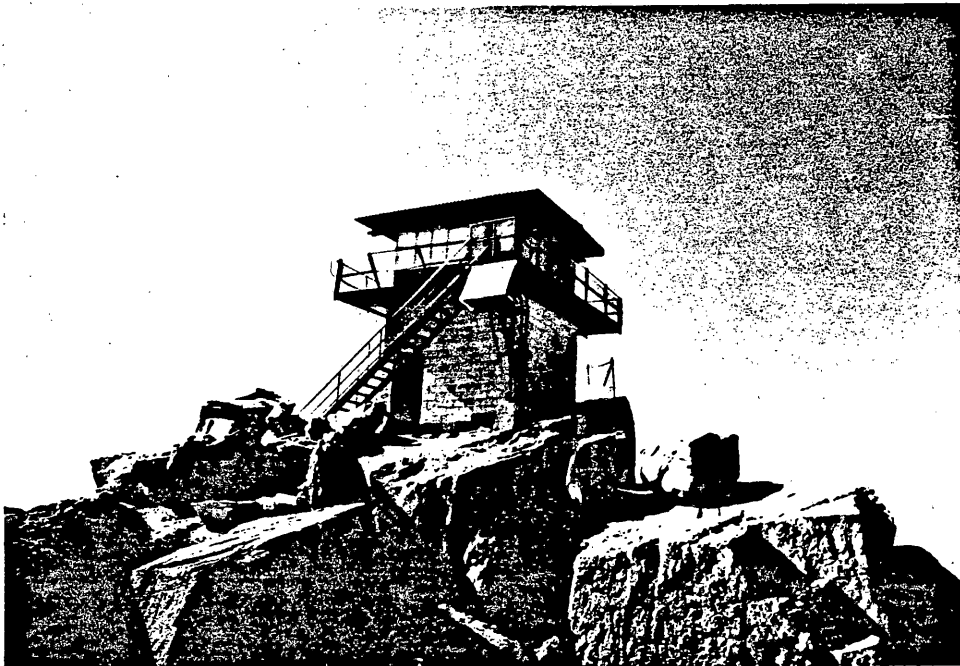
CL10 revised to C16. Sierra Buttes, Tahoe N. F.

- 26) In 1949 Region 5 dropped restrictions on K-brace tower heights.³⁴
- 27) In 1951 Region 5 adopted an all "ferrous sheet metal" (live-in) 13' X 13' cab with flat roof designed by the Washington D.C. office (design CL-104).³⁵ About this same time Region 5 began constructing cinder block towers.³⁶ See Plate 22.
- 28) In 1969, California Department of Forestry engineer, Mike Plesha, introduced a standard woodframe cab with tilted windows as a replacement for the more expensive 809R design.³⁷ See Plate 23.
- 29) In 1974 Region 5 architect, Robert Sandusky, designed a hexagonal wood frame cab.³⁸ See Plate 24.
- 30) In the early 1980s, the California Department of Forestry began erecting General Services Administration surplus steel atomic test towers.³⁹ See Plate 25.

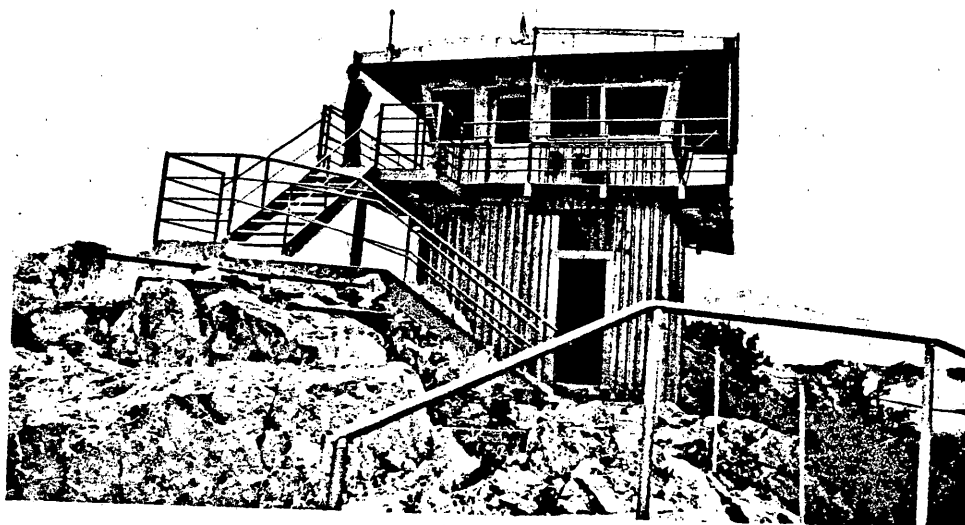
PLA on NEWF. Duzel Rock, Sierra-Cascade Region, C.D.F.
